Some Misunderstandings Related to WTC Collapse Analysis

Gregory Szuladziński, Anthony Szamboti and Richard Johns

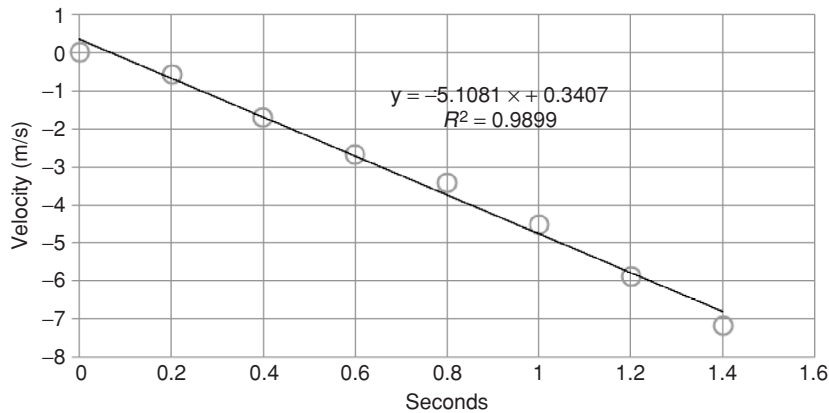
Figure 1. Measured initial velocity of the North Tower fall

Now, let us have a look at the numerical values. The velocity of the falling roof of the North Tower was measured in [7] and the initial phase over the first 1.4 seconds is shown in Figure 1.

The averaged acceleration during the early phase of the fall (shown as the slope of the velocity curve in Figure 1) was approximately 5.11 m/s^2. The resulting velocity after 1.2 seconds of the fall, which is the approximate time for a fall of one story (3.7 m), is 6.13 m/s (13.71 mi/h).

To keep in contact with reality, one should note that Fig.1 shows the measured velocity developed at the end of the fall over the critical story to be much larger (6.13 m/s) than the speed implied by the PCF mode. This is simply another indication that PCF is not a proper explanation of the process.
